# GEOTECHNICAL INVESTIGATION OF SLAB MOISTURE INTRUSION

BRIDGEPORT  
ELEMENTARY SCHOOL  
(SAUGUS UNION SCHOOL  
DISTRICT)

23670 Newhall Ranch Road  
Santa Clarita, California

July 19, 2017  
FN 05725-01

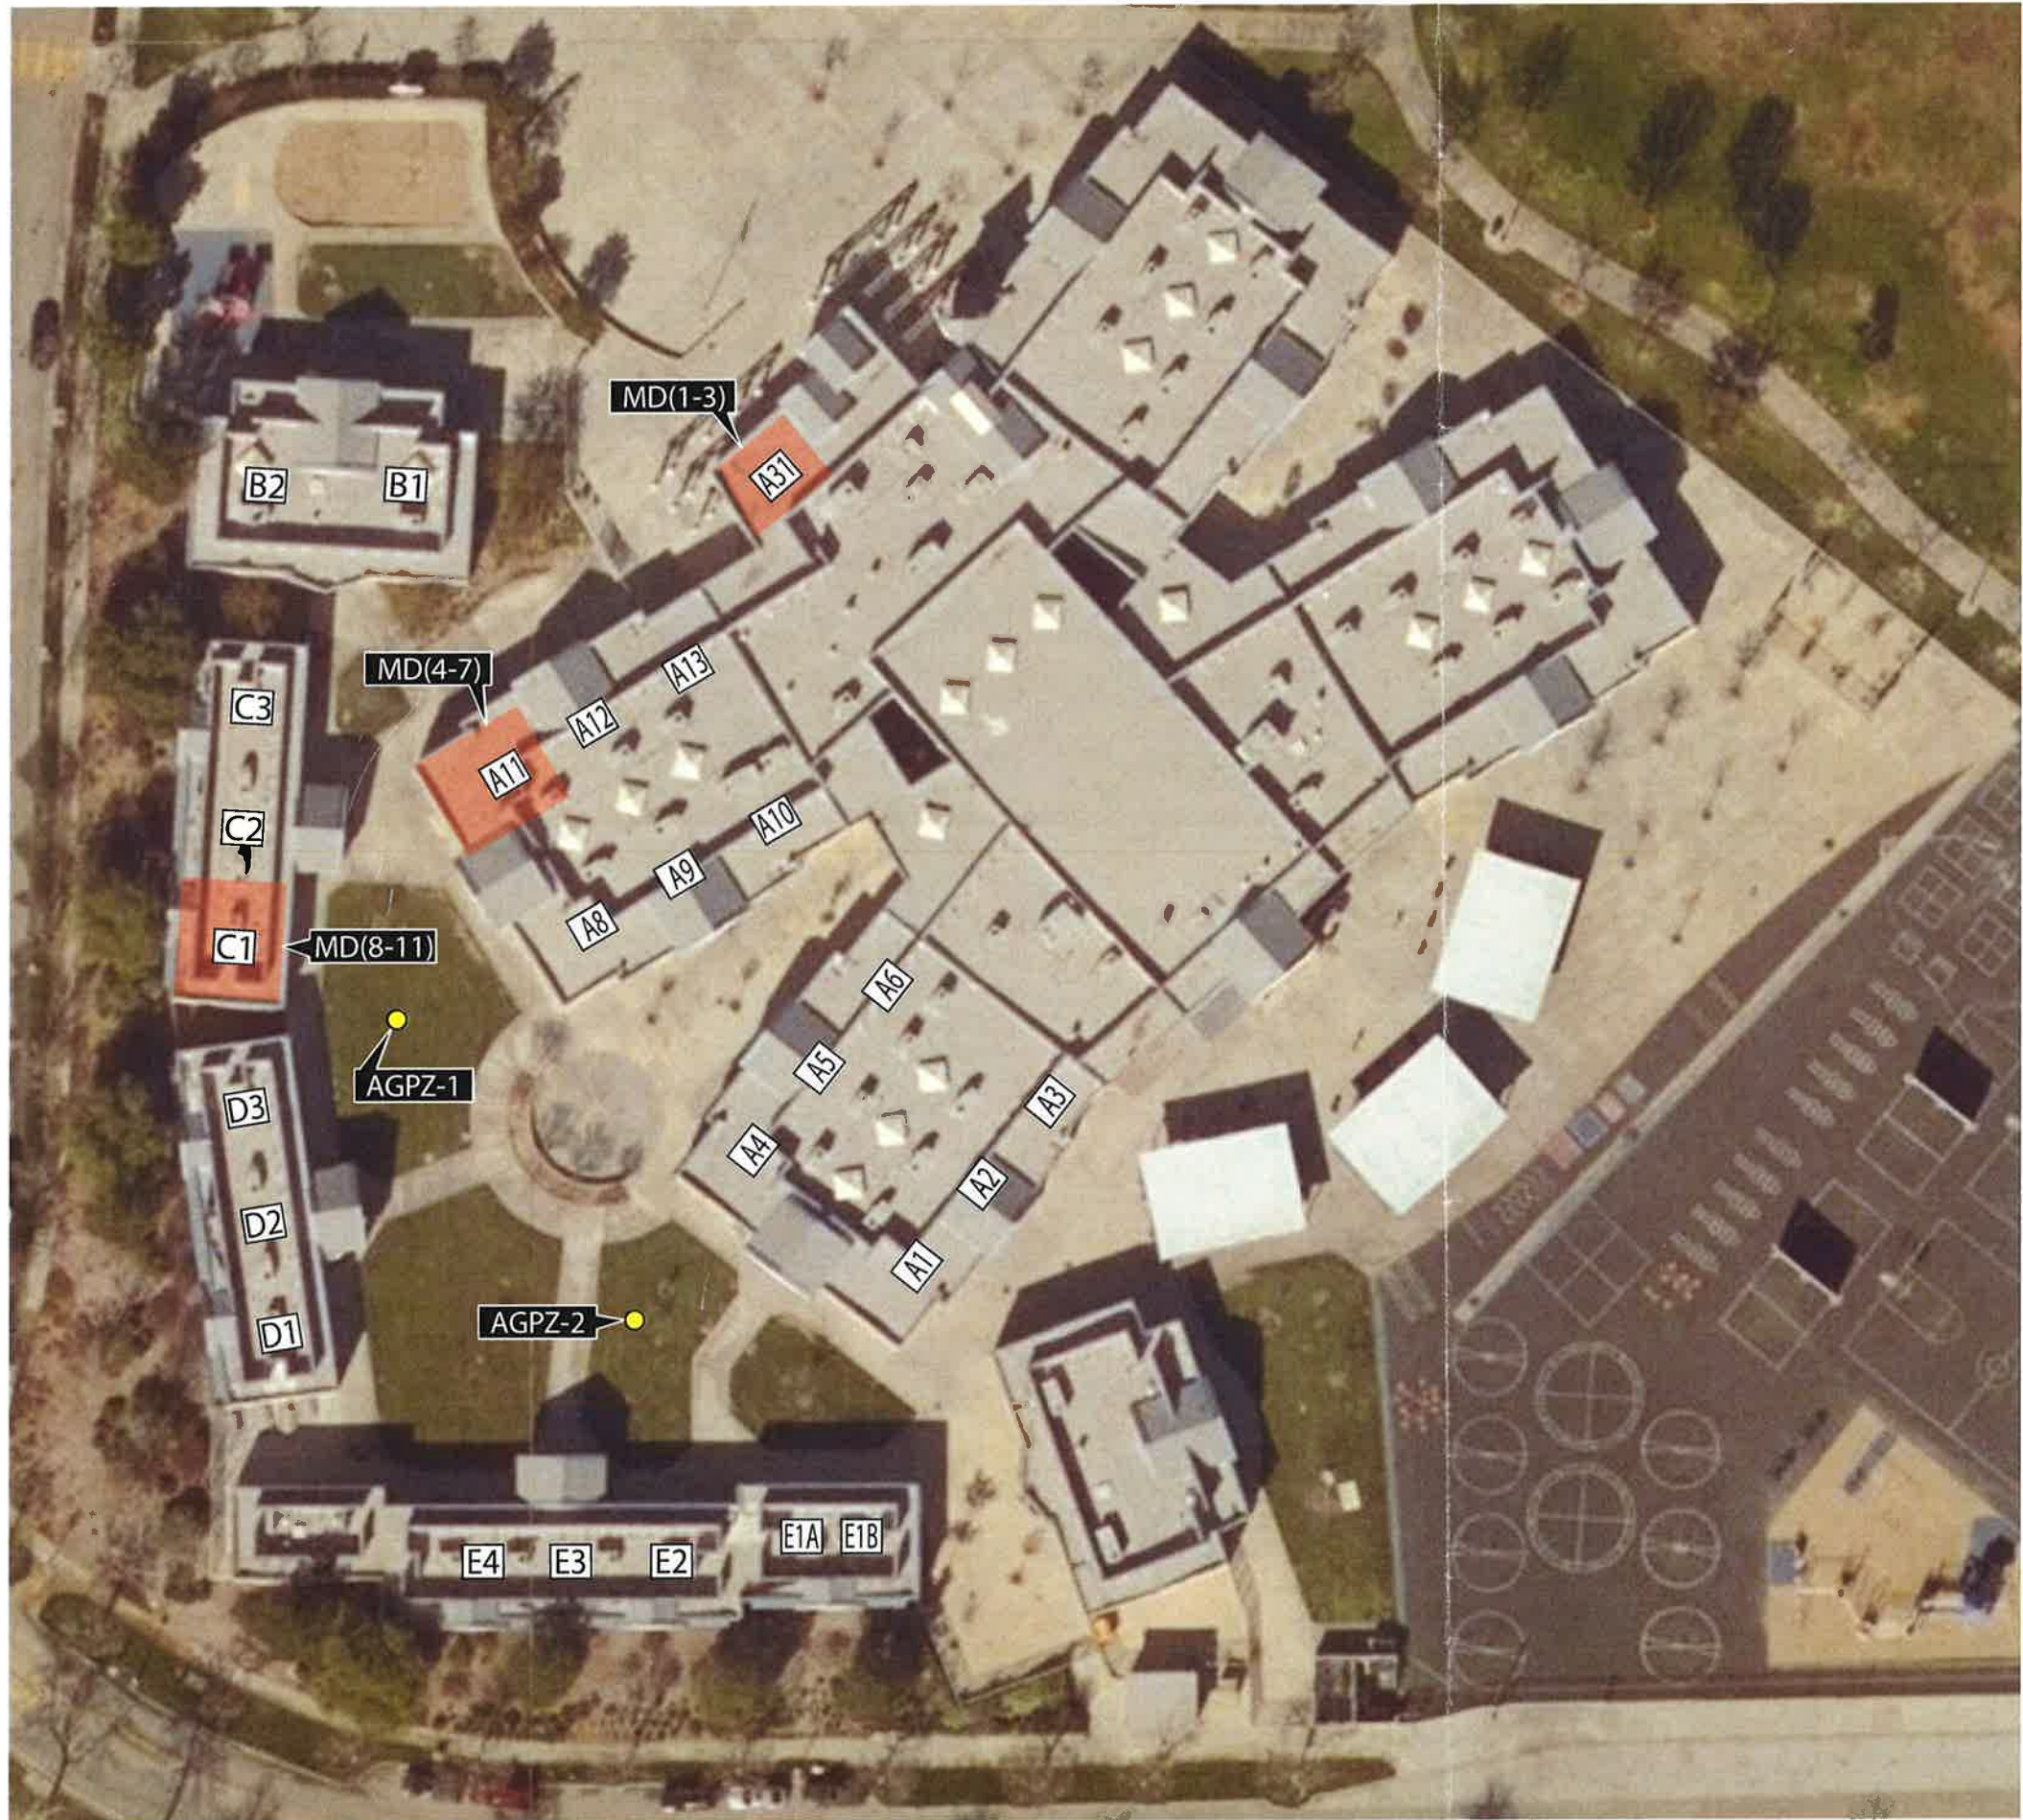
American Geotechnical, Inc. F.N. 5725.01	<b>Test Location Plan</b> Bridgeport Elementary School Santa Clarita, Ca	<b>Figure 1</b>

The concrete slab foundation was tested for moisture vapor emission in three school rooms, which included the teacher staff room A31, and the classrooms A11 and C1 (see **Figure 1** for classroom locations). The moisture dome test method was utilized to measure the moisture vapor emission rate of the slab surface in general conformance with ASTM Standard F-1869. A total of 11 tests were performed. However, one of the moisture domes was disturbed during the test period, which invalidated the test results at that location. The remaining 10 tests yielded moisture vapor emission rates ranging from 4.2 to 8.5 lbs per 1,000 square feet of floor area per day. The average moisture vapor emission rate for all 10 tests was 6.34 lbs per 1,000 square feet per day. The test results are presented in **Table 1**. The measured vapor emission rates are higher than the maximum allowable value of 3-5 lbs per 1,000 square feet per day specified by most flooring manufacturers.

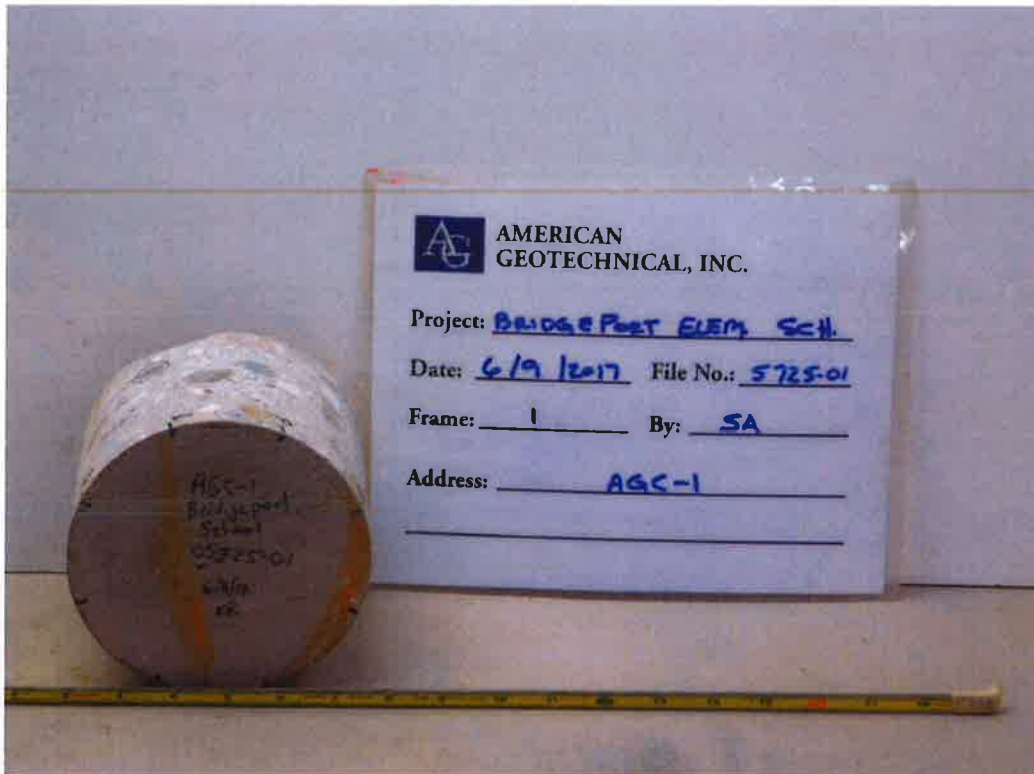
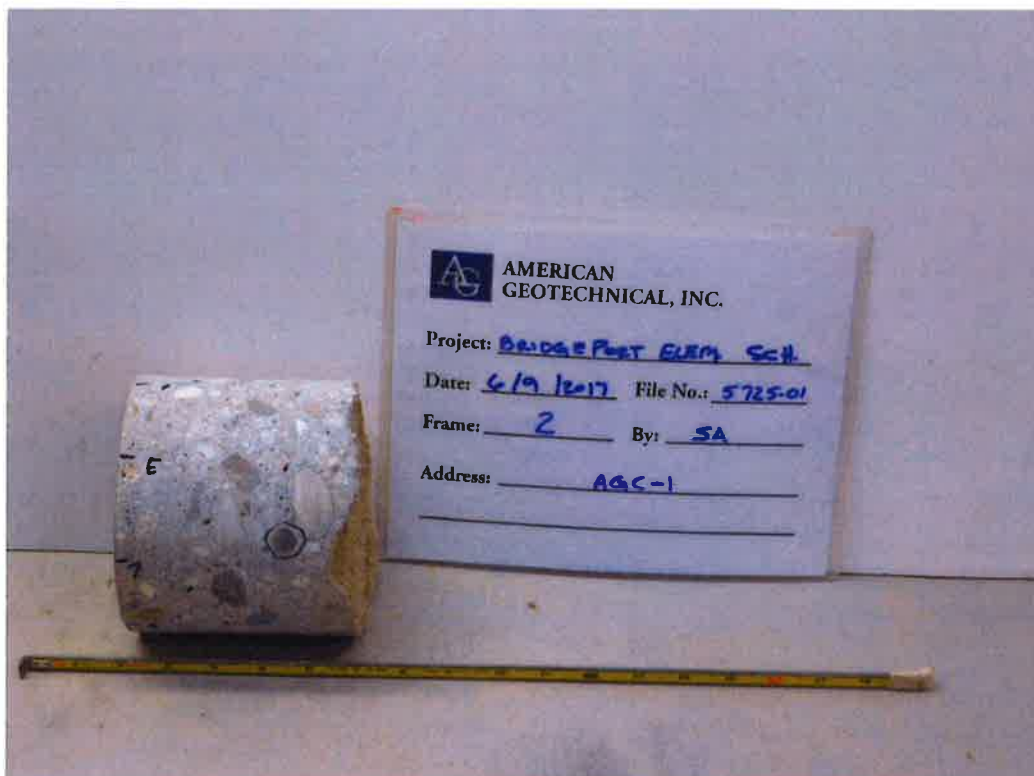
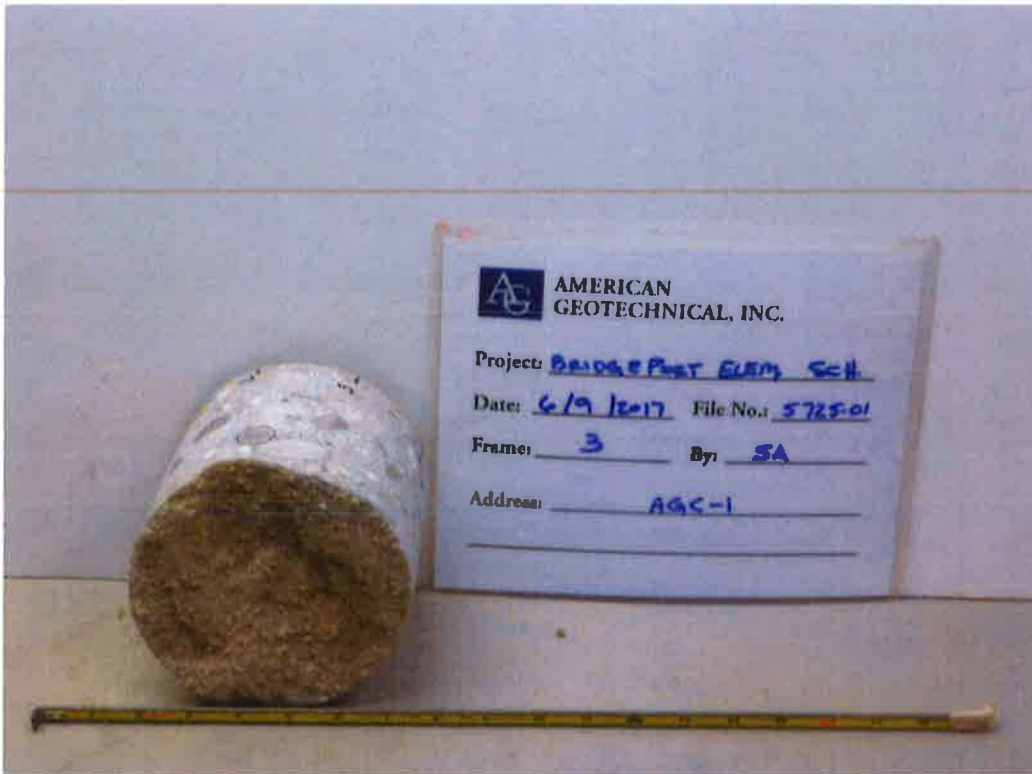
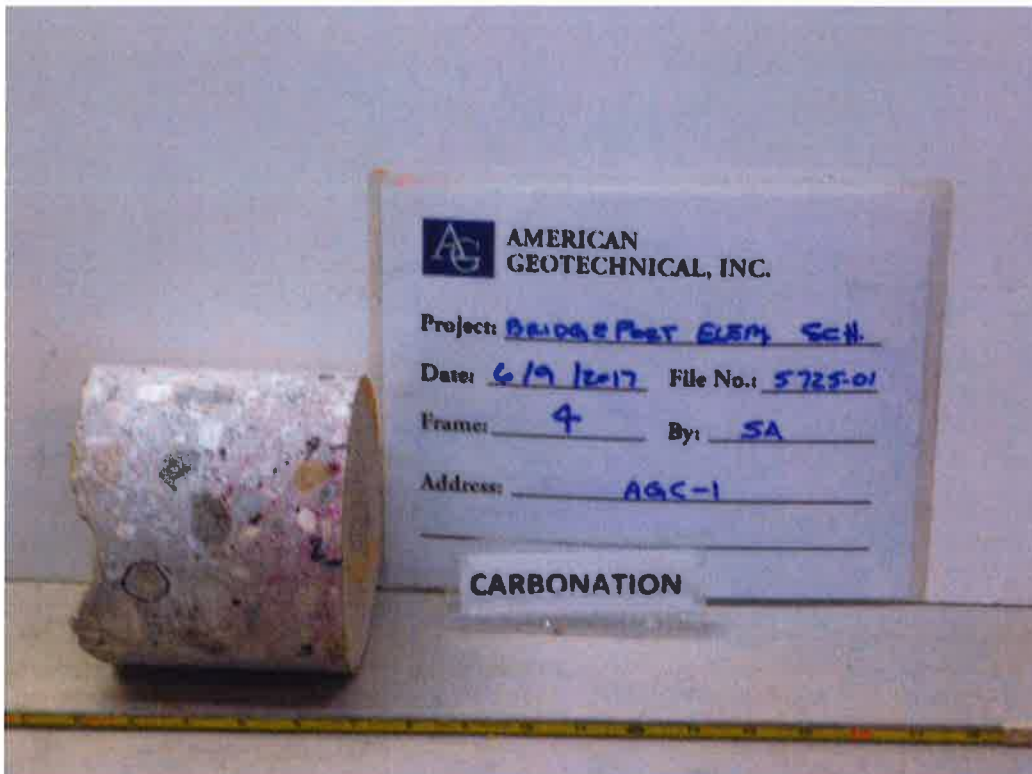
LARGEST ROCK FRAGMENT 1.22 INCHES AIR BUBBLES  YES  NO

COMMENTS AIR POCKETS / INCOMPATIBLE HANDOUT YELLOW (STE 190?)

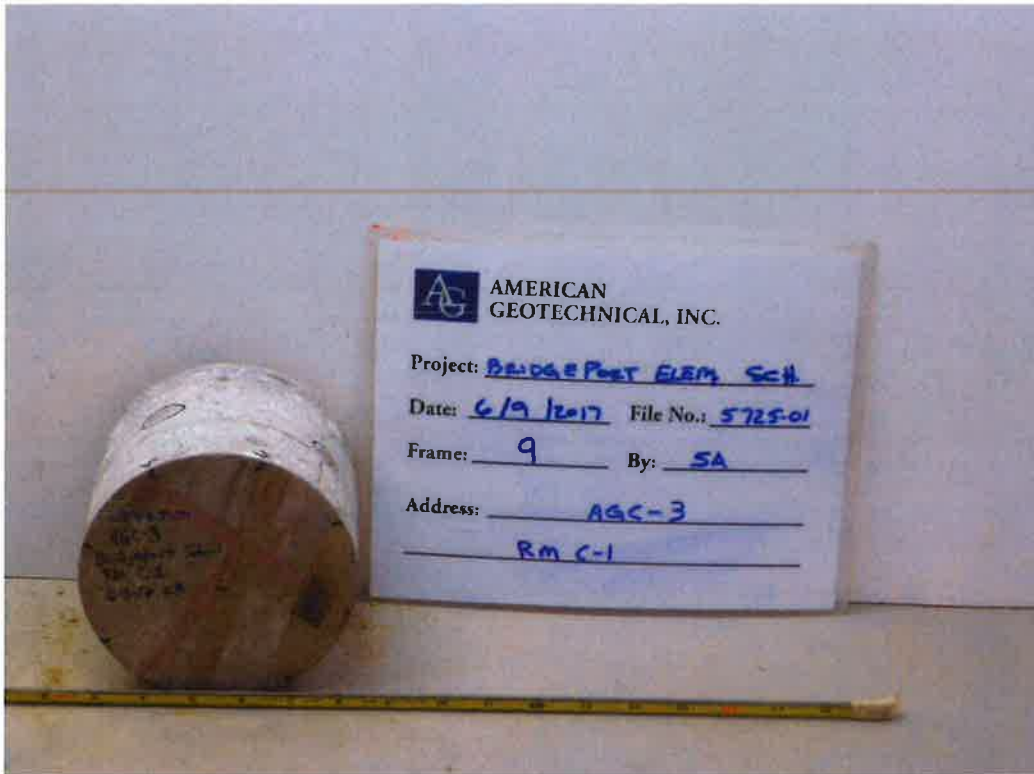
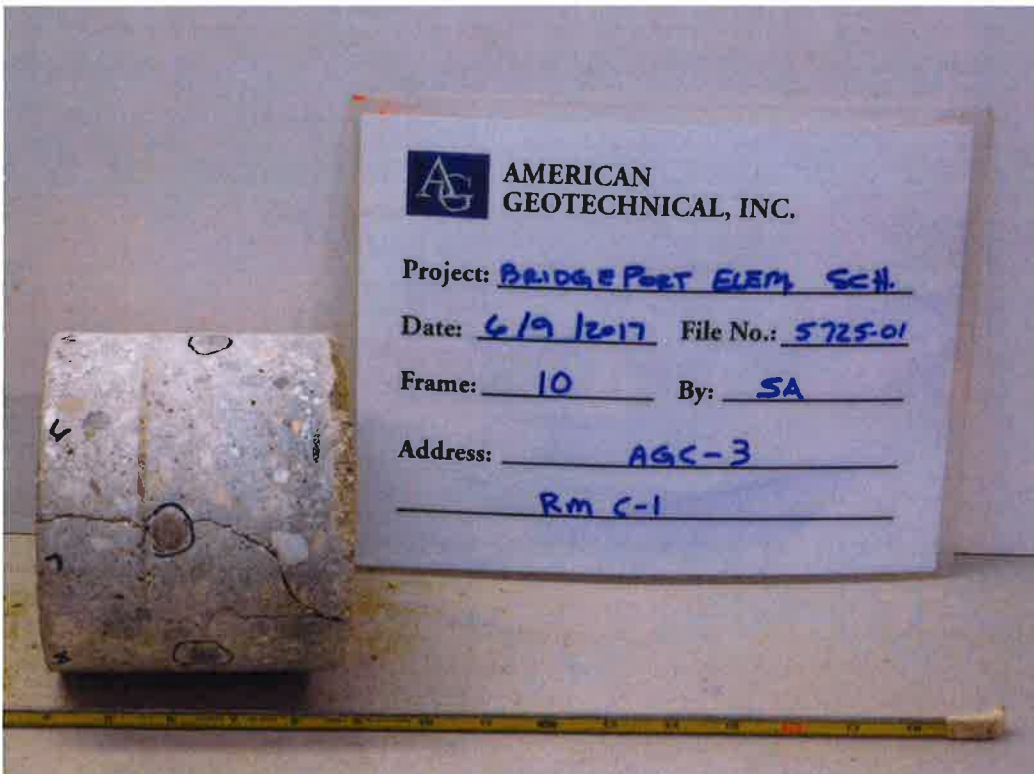
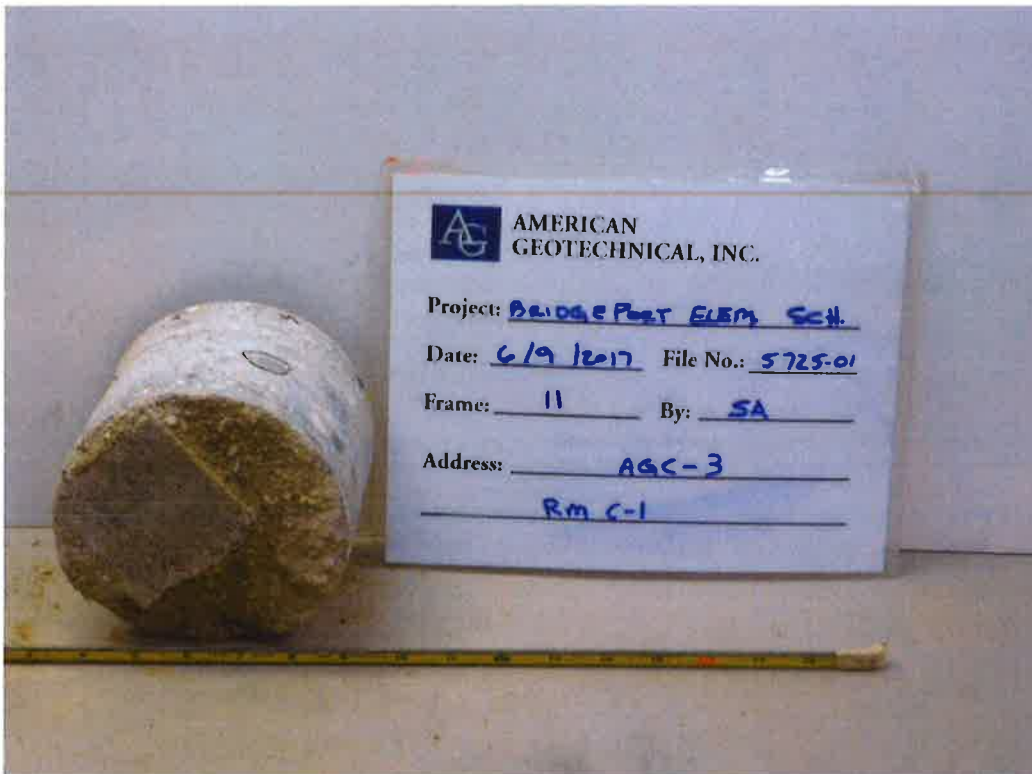
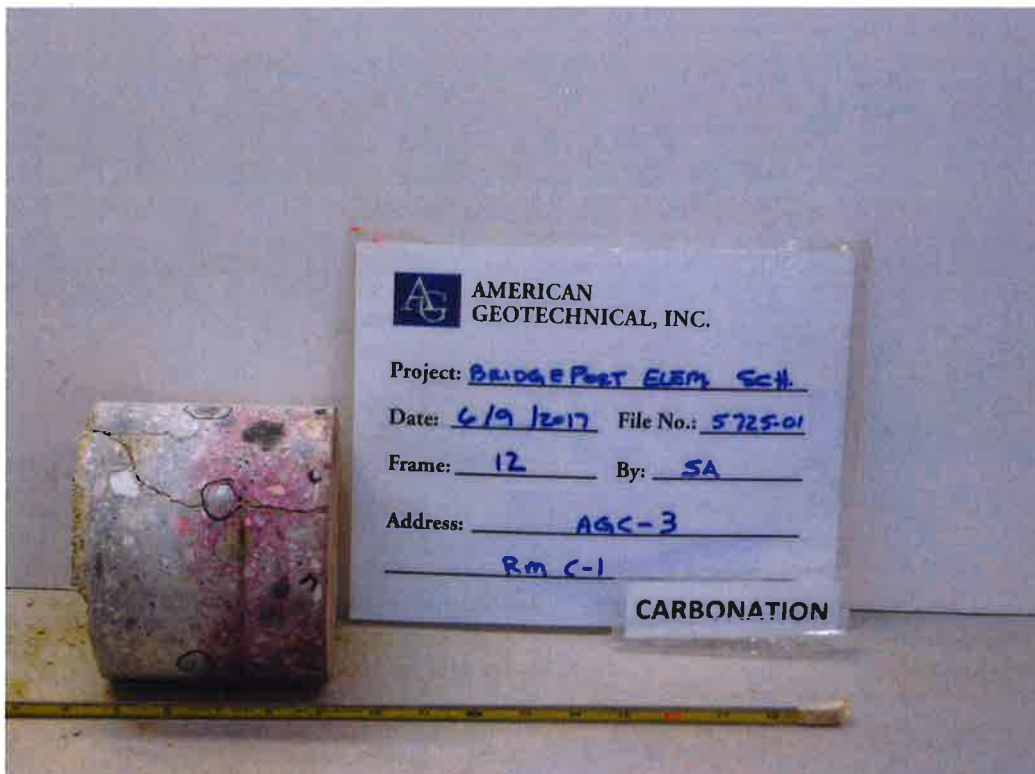
COMMENTS CRACK COMPLETELY THROUGH THE CORE.

MEMBRANE - STEELCO yellow 15 mil HAND CUT
