November 15, 2017

Subject: Focused Indoor Environmental Quality Inspections at Emblem,
North Park, Mountain View, and Bridgeport Elementary Schools
Saugus Unified School District, Valencia, California
Exponent Project No. 1703766.000, Task 0501

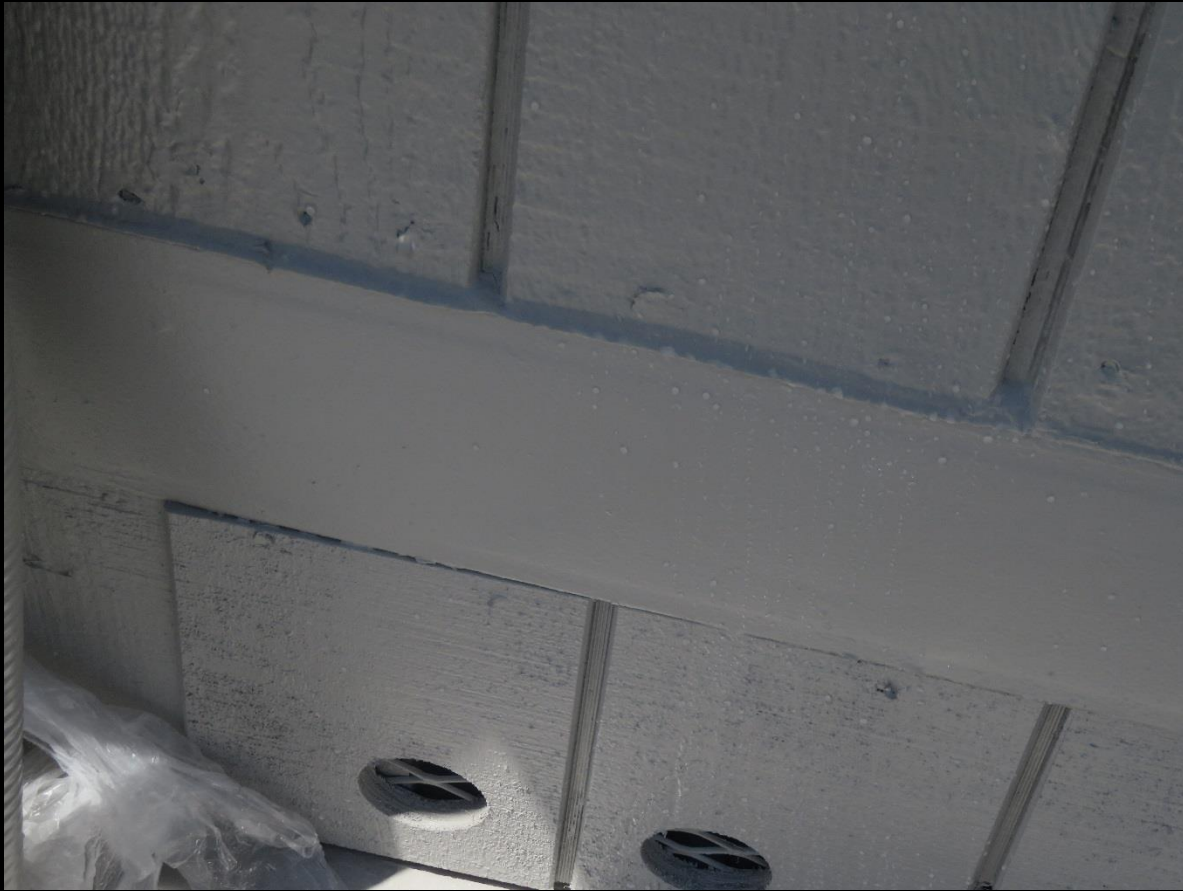
- Condensation drains should be inspected to assure that they drain outside of the AHU and some distance away from the structure to avoid water accumulation near the foundation of the portable classrooms. Some of the portable classrooms had drain lines that dripped on the portable's exterior siding (Photo 1).

Photo 1. Condensate Line Dripping on Siding, Unit 39A, Emblem Elementary

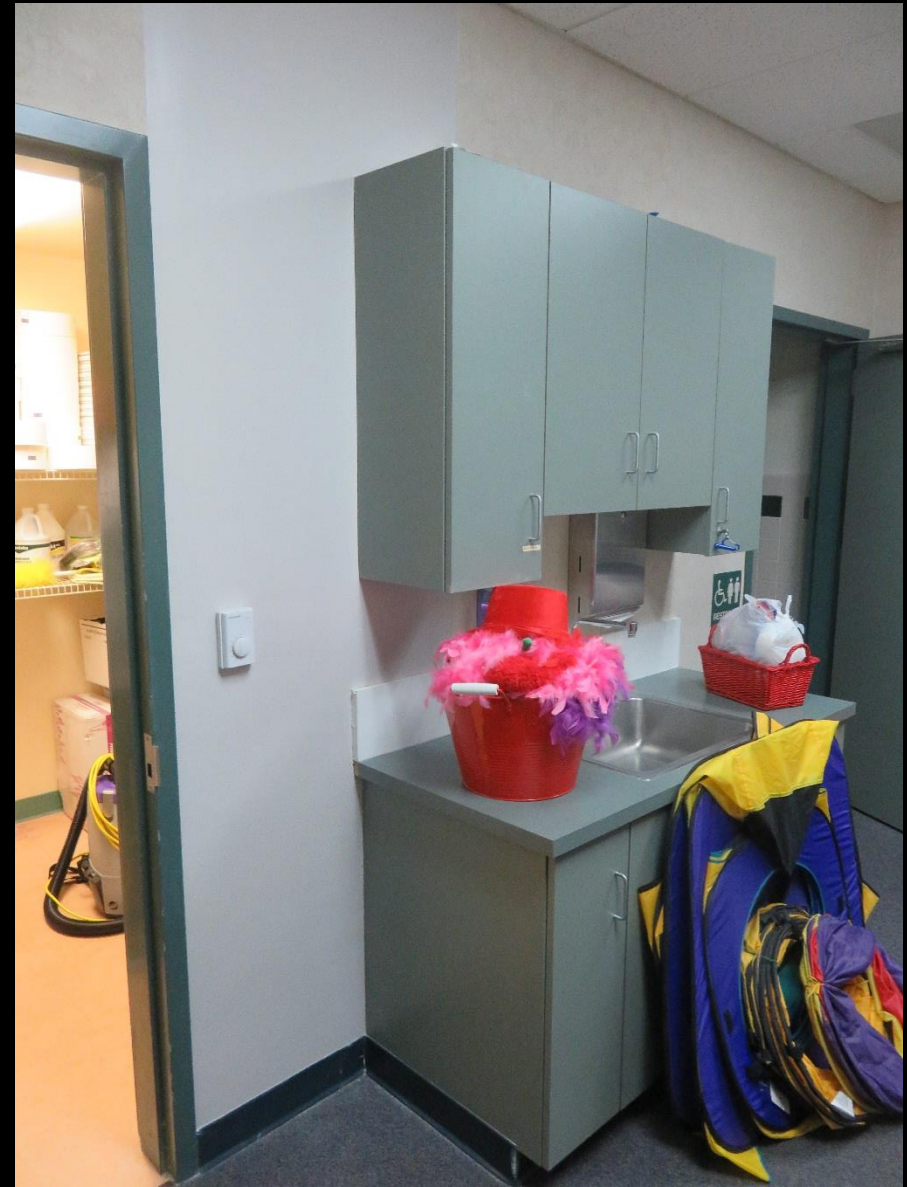
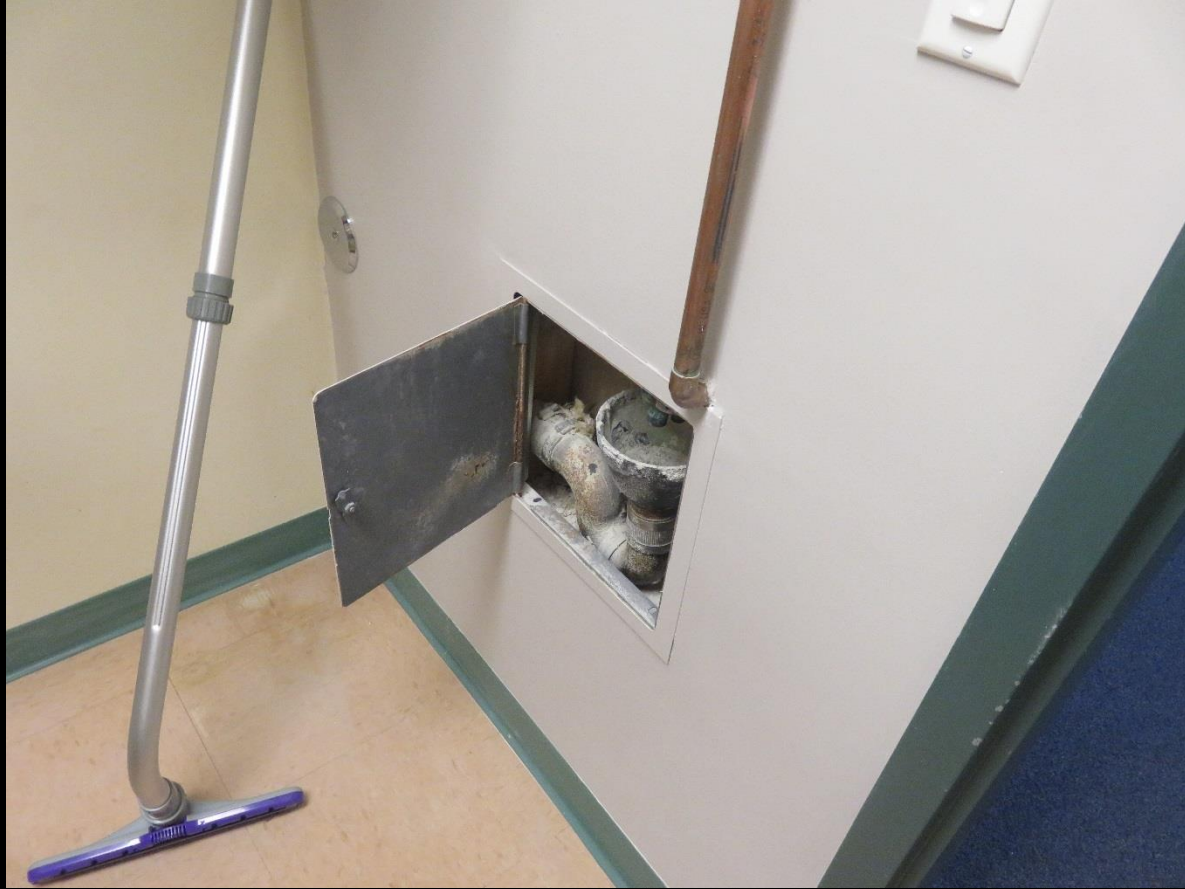
A water heater relief drain reportedly leaked and caused staining and possible fungal growth on some building materials in a shared utility room between Kindergarten 1 and Kindergarten 2 rooms (Photos 2 to 3). Custodial personnel informed us that possible fungal-impacted drywall was removed from the area surrounding the sink and near the water heater, which had been identified during the repair. This condition was discovered and was repaired during the Summer Break of 2017, prior to Exponent's inspection. Based on our review, no elevated moisture or visible fungal growth was observed on the construction materials that were present in this area at the time of our inspection. There were no obvious odors consistent with fungal growth noted in these repair areas. There was some residual, visible, construction dust remaining on some surfaces in the immediate area and were primarily concentrated on the floor. The work practices and controls used by the repair contractor related to this work were unknown.

Photo 2. Remediated Area, Classrooms 1 and 2, North Park Elementary

Photo 3. Remediated Area, Classrooms 1 and 2, North Park Elementary

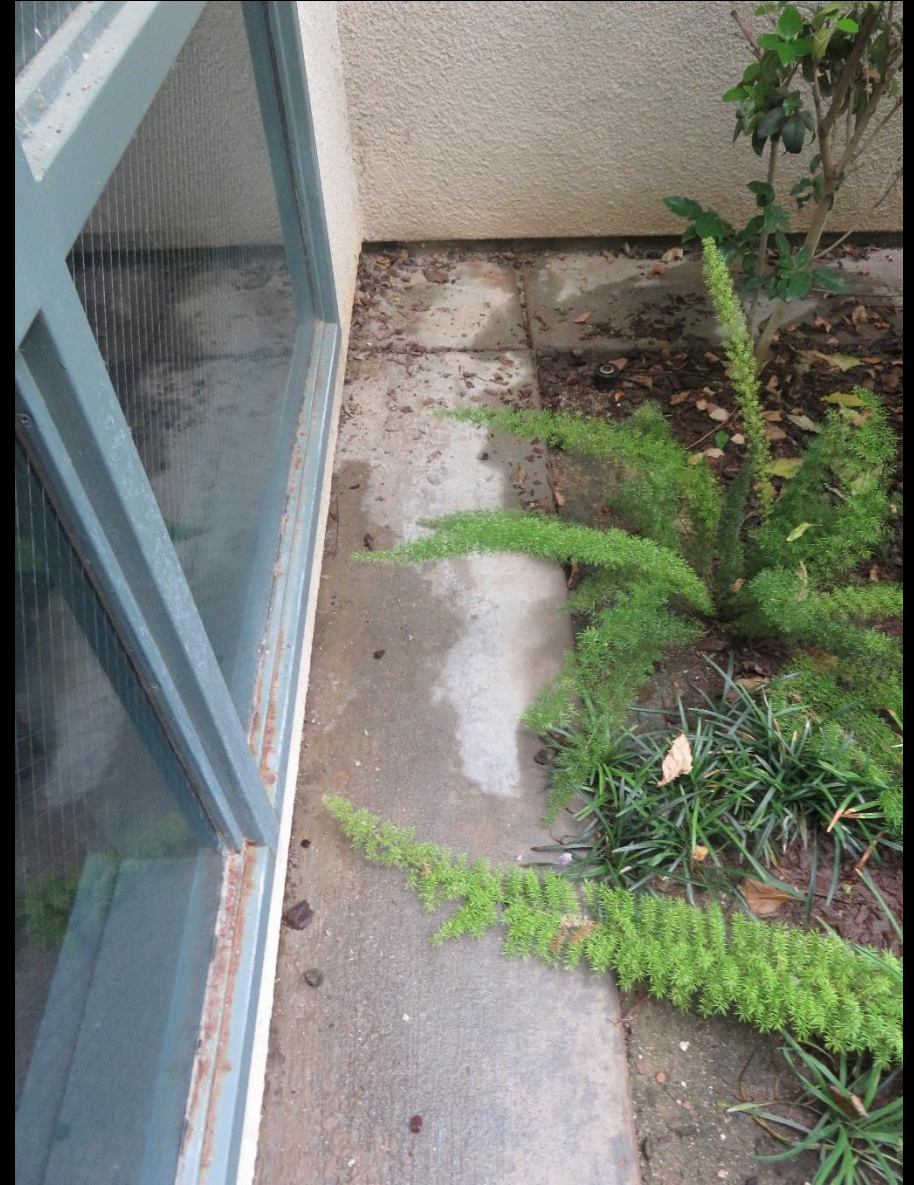
An atrium located near the entrance and main reception area was observed to have areas of water staining and possible historical flooding (Photos 4 and 5). No drain in this area was observed. This area's irrigation system should be inspected, repaired, and possibly modified to reduce the direct impact of water against the building exterior.

Photo 4. Atrium, Staining on Concrete, North Park Elementary

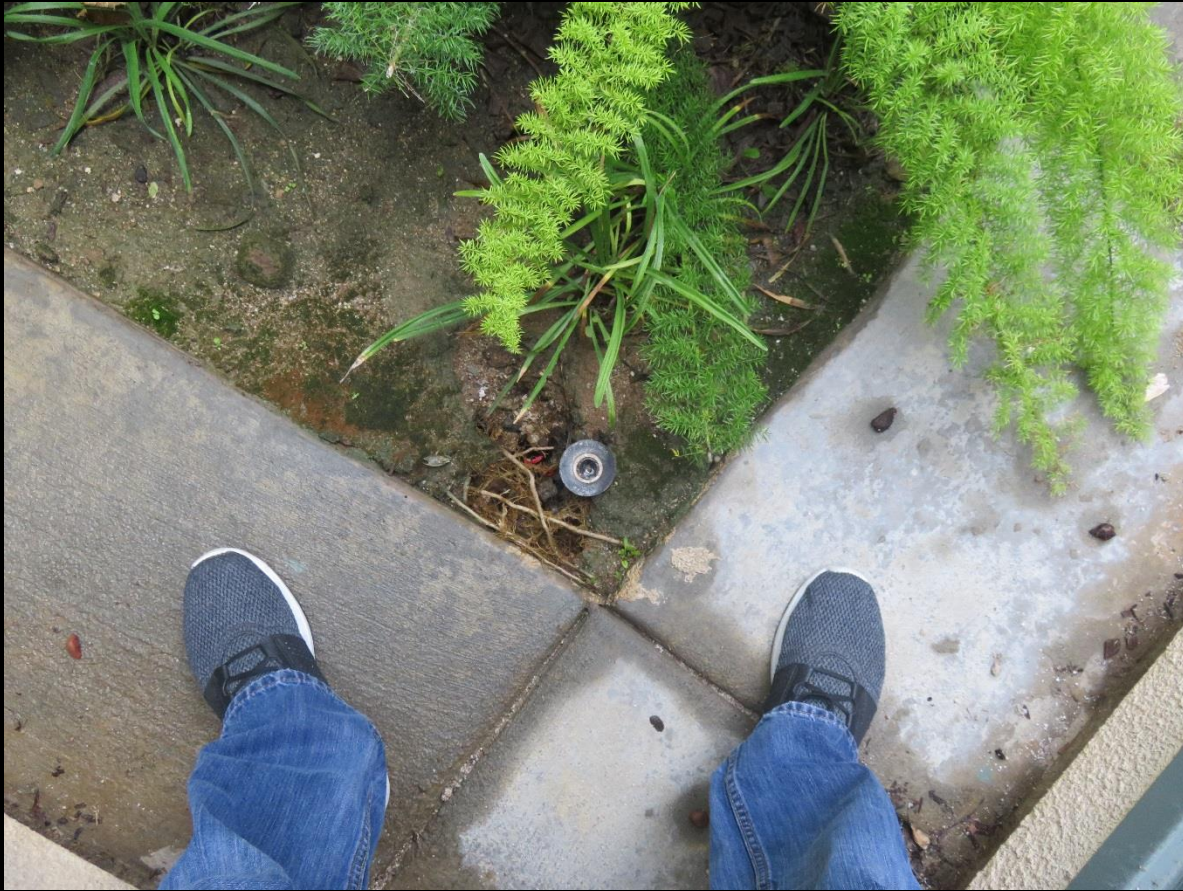
Photo 5. Atrium, Possible Broken irrigation Line, North Park Elementary

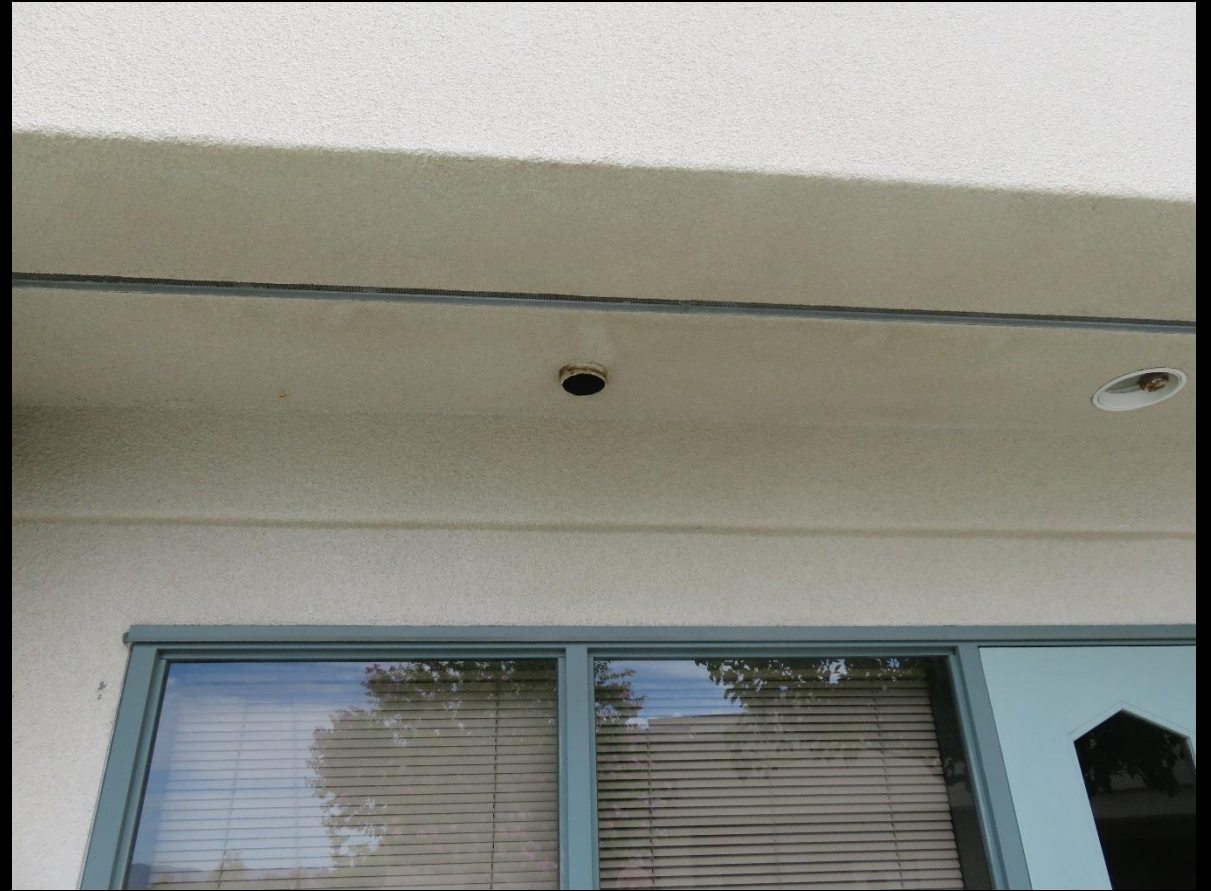
We noted that the rainwater downspouts terminated immediately outside of the buildings, which allows for storm water to pool on the concrete adjacent to room entry points and the building foundations. Ideally, these termination points would carry water away from the building foundation (Photos 6 and 7). Further, staining due to possible impact from irrigation water was observed on some buildings (see exemplar Photo 8).

Photo 6. Representative Downspout Outside of Classroom, North Park Elementary

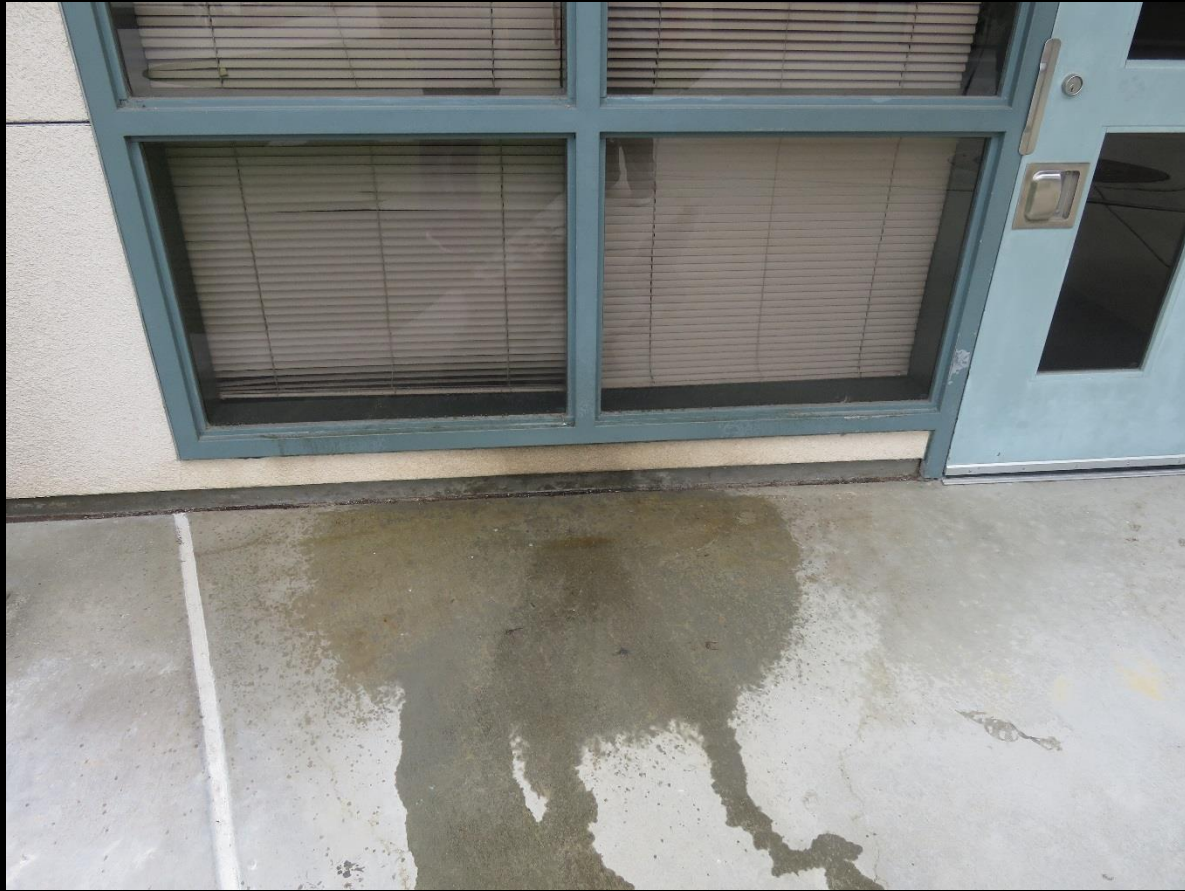
Photo 7. Stain on Ground below Downspout, North Park Elementary

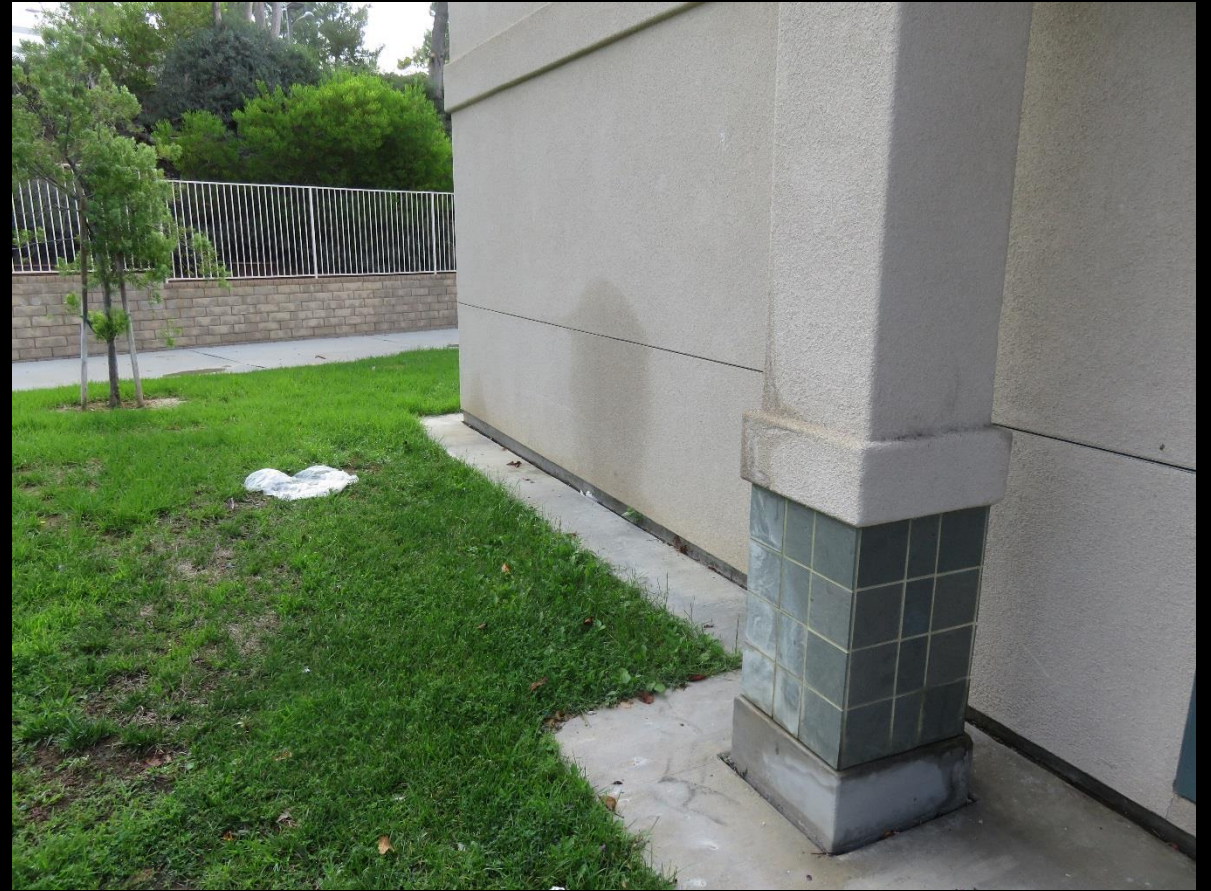
Photo 8. Possible Irrigation Water Stain on Building Exterior, North Park Elementary

- Irrigation watering systems should be evaluated and adjusted to prevent irrigation water from hitting the exterior of the building. This was observed on buildings at North Park and Bridgeport Elementary Schools.

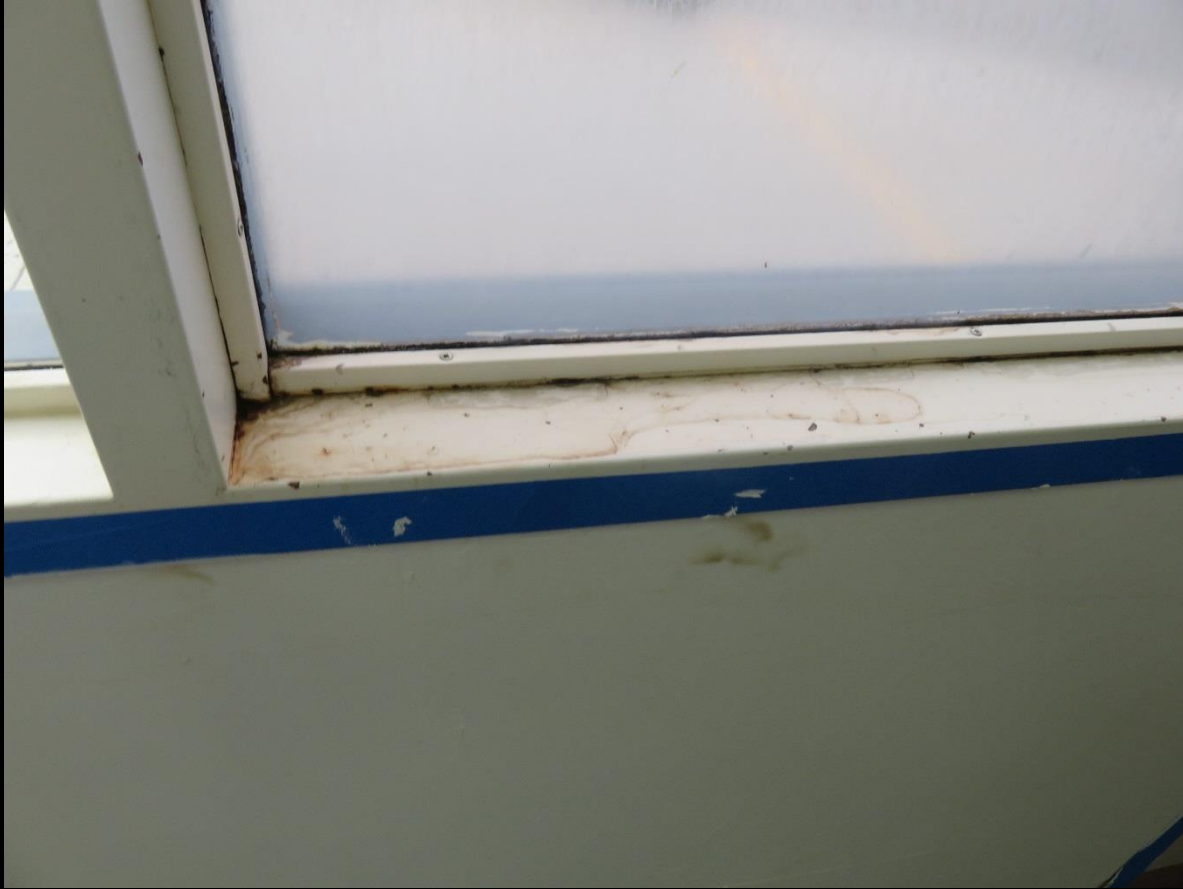
As noted in Table 1, these classrooms had some previous repairs that had occurred around exterior windows to address moisture intrusion and possible fungal growth on building materials, as reported by school staff at the time of our inspection. No evidence of current fungal growth, odors consistent with fungal growth, or elevated moisture within existing building materials was noted at the time of our inspection.

Photo 9. Staining on Window Sill at Remediation Location, Mountain View Elementary

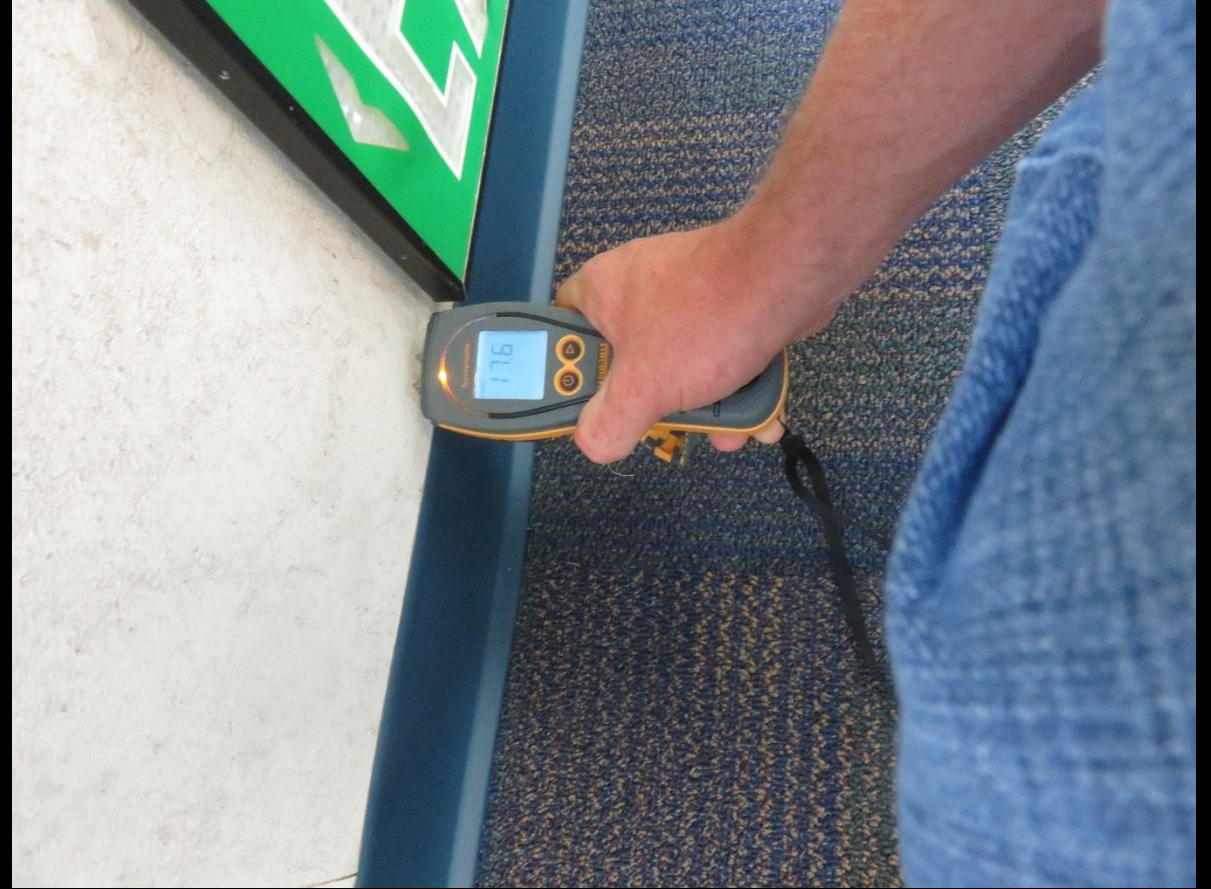
In classroom C1, Site custodial personnel reported that a small area (<10 square feet) of stained and possible fungal growth on vinyl wall paper was identified near the entry door after the concrete sealing occurred in the summer of 2017. Site custodial personnel attributed this condition to the covering of the classroom walls with plastic during the concrete slab sealing activities. The custodial personnel reported that they cleaned the area with a dilute bleach solution, and the vinyl wall paper was replaced. During our inspection, we did not observe residual staining or fungal growth on the accessible surfaces. There was a small area adjacent to the lower left of the exit sign along the base cove molding that tested slightly damp with a moisture meter (Photo 10). This area was a few square inches in size. All other surfaces tested with the moisture meter were dry. In room C1, there was some evidence that irrigation water may be hitting the windows and possibly the exterior wall (Photo 11).

Photo 10. Wet Drywall Near Exit Sign, Classroom C1, Bridgeport Elementary

- For Classroom C1 at Bridgeport, a small area near the entry door was reportedly cleaned a week prior to my inspection. There was a small area adjacent to the lower left of the exit sign along the base cove molding that tested slightly damp with a moisture meter. This area should be monitored by custodial personnel for the presence of moisture. If moisture persists, then additional investigation will be necessary.

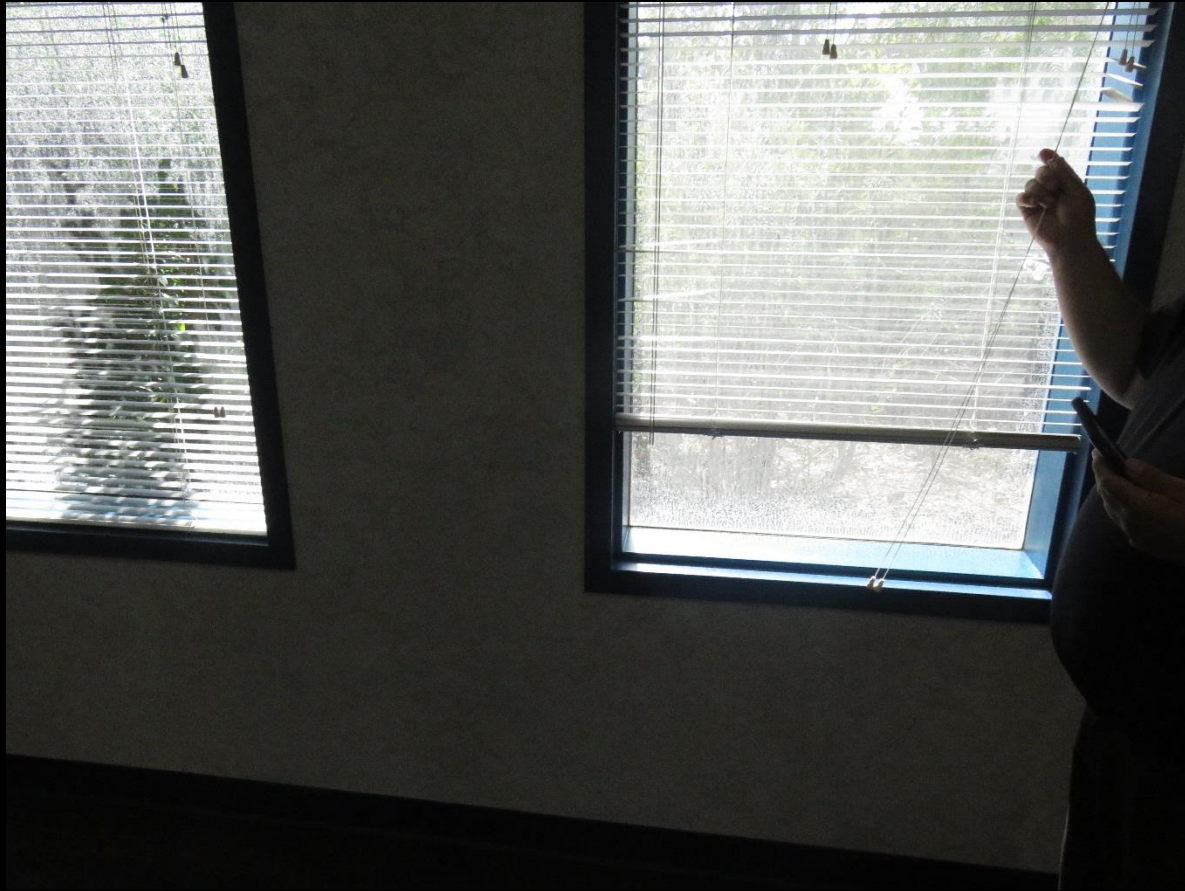
Photo 11. Hard Water Staining on Window, Bridgeport Elementary
