Exponent
475 14th Street, Suite 400
Oakland, CA 94612

Subject: Focused Destructive Inspection at Bridgeport Elementary School
Saugus Unified School District, Valencia, California
Exponent Project No. 1703766.000

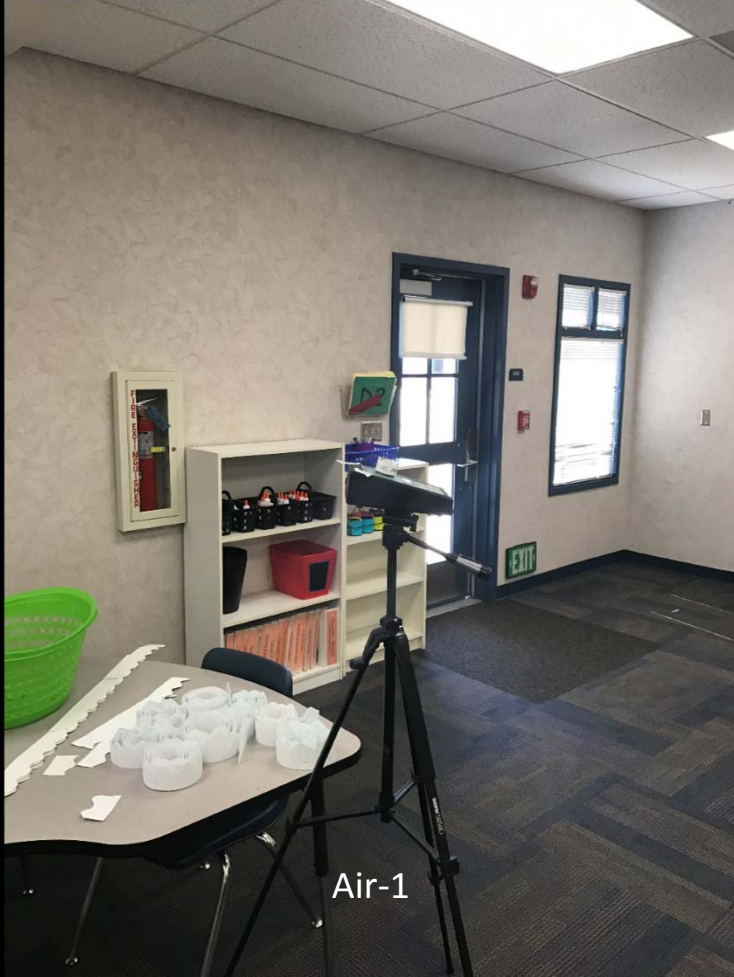
Air was passed through each sampling cassette by an electrically-driven, high-volume air-sampling pump calibrated at a flow rate of 15 liters per minute by use of a precision rotameter that had been calibrated against a primary standard. The sampling cassettes were placed approximately four to five feet above the floor surface on a tripod stand (i.e., breathing zone height) and away from walls or other obstructions. Each sample was collected for five consecutive minutes. A field blank sample was collected for quality control purposes during the evaluation. A field blank identifies contamination as a result of collection and transport of the samples and is collected by handling the Air-O-Cell[®] spore trap cassette media in the same manner as the samples except that the field blanks were not used to sample the air. A representative photograph depicting the sampling setup is shown in Photo Air-1 in Attachment A.

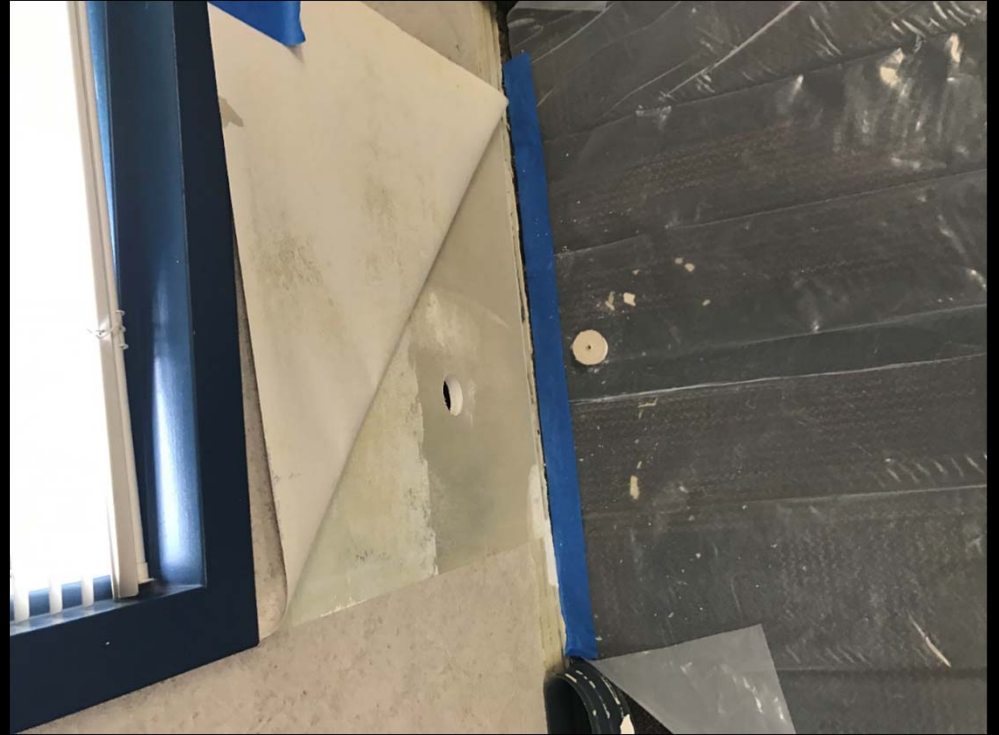
A8-1

In Classroom A8, a slight musty odor was noted upon entering the room. Staining beneath the carpet tiles was noted in some areas and this may be a source of odor. These observations of water and staining beneath the carpet tiles were consistent with historical observations made at the site during previous inspections. As noted below, the observations during wallpaper lifting, removal of base molding, and inspection of wall cavities in Classroom A8, did not reveal signs of fungal growth.

- Based on the observed staining and visible moisture under the carpet tiles noted in this report, further investigation as to the extent and cause of the moisture intrusion is needed. This may involve consultation with additional flooring experts and materials scientists to find a solution to the issue.

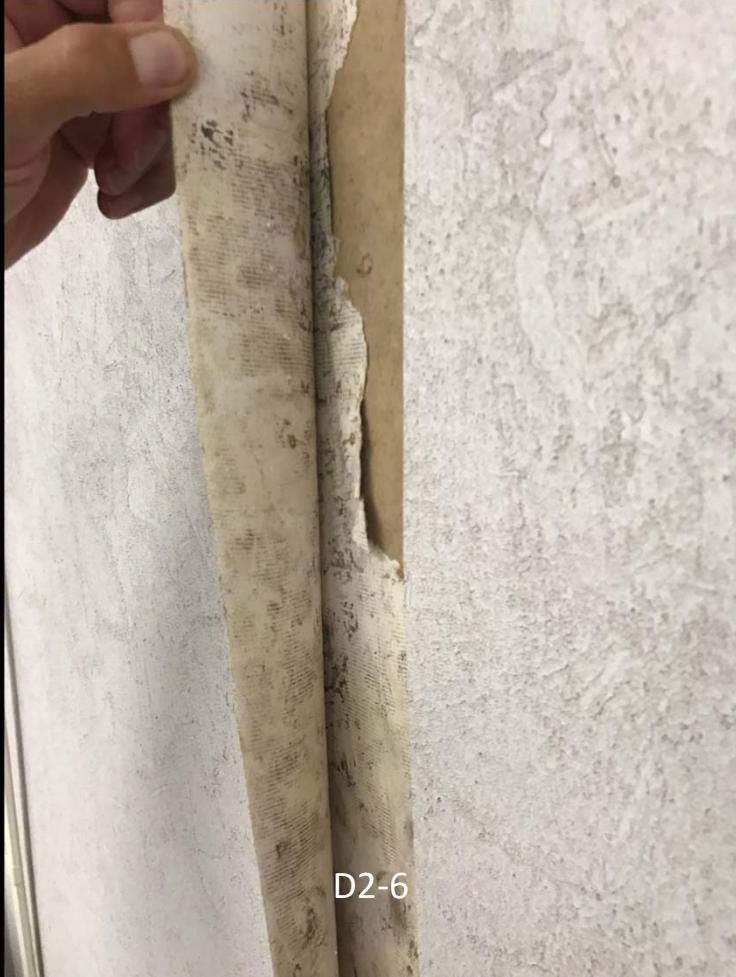
D2-6

Wall surfaces under 40 areas of wallpaper were examined. In two small areas, in two different classrooms, unusual staining was observed when the wallpaper was lifted. In classrooms E3 and D2, there was visible staining located on the backing of the wallpaper and on the exposed drywall when lifted. These findings were localized to an area beneath an exterior window on the south elevation (Room E3) and approximately six feet from the ground on an exterior wall on the west elevation in one room (Room D2). Surface samples were collected and are discussed in the section below. Any released dust was cleaned by use of a HEPA vacuum and wet wiping. Air sampling was also conducted in each of these rooms after the hole in the wall was patched. An obvious cause of these stains was not found. It is possible that an object was rested against these areas for a period of time trapping atmospheric moisture (humidity), but a complete determination as to the cause of the leak was not made by Exponent and we recommend that it should be investigated further by the School District, as noted in the summary at the end of this report. Representative photos of these areas in Rooms E3 and D2 are included as photographs E3-3 to E3-4 and D2-6, respectively, in Attachment A.

The laboratory results for the surface samples are presented in Attachment B. The stains noted behind the wallpaper in rooms E3 and D2 were associated with fungal growth. The surface samples collected in Room E3 (Sample E3-T1) showed the presence of fungi primarily dominated by *Aspergillus/Penicillium-like*, which is a type of fungi that is commonly found on wet building materials, including drywall. Colonies¹ of *Mucor* and *Penicillium* were also identified in the sample collected from Room E3. In Room D2 (sample D2-T1), there were similar findings with *Aspergillus/Penicillium-like* fungi dominating the sample, with some colonies of *Aspergillus*. In addition, hyphal fragments were identified in both of these samples at an elevated qualitative level (TNTC)², which indicates fungal growth was or is likely present in these areas.

- The areas identified in Rooms D2 and E3 should be remediated by a licensed mold remediation contractor following standard industry practice at the conclusion of the 2018 school year. Stained and affected building materials should be removed (including any drywall, any stained insulation, and wallpaper, if within the impacted area). The full extent of these stained areas was not determined during this inspection, particularly for the area observed in Room D2. The source of the leak or source of water should be identified and repaired prior to remediation. After remediation, a post-remediation inspection should be conducted by a third party inspection.
