# GEOTECHNICAL INVESTIGATION OF SLAB MOISTURE INTRUSION

BRIDGEPORT  
ELEMENTARY SCHOOL  
(SAUGUS UNION SCHOOL  
DISTRICT)

23670 Newhall Ranch Road  
Santa Clarita, California

July 19, 2017  
FN 05725-01

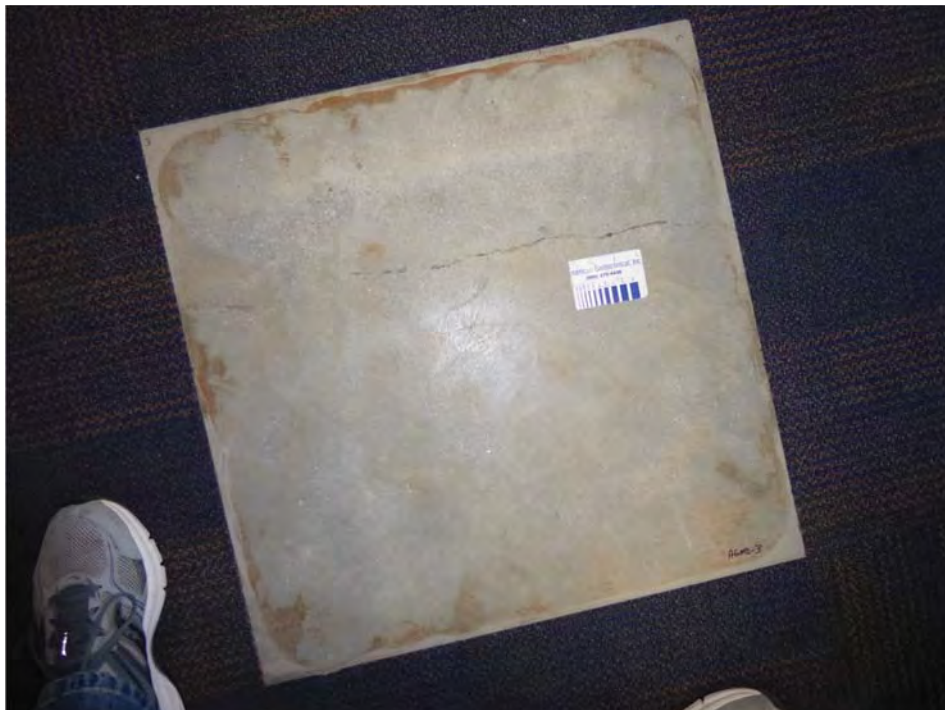
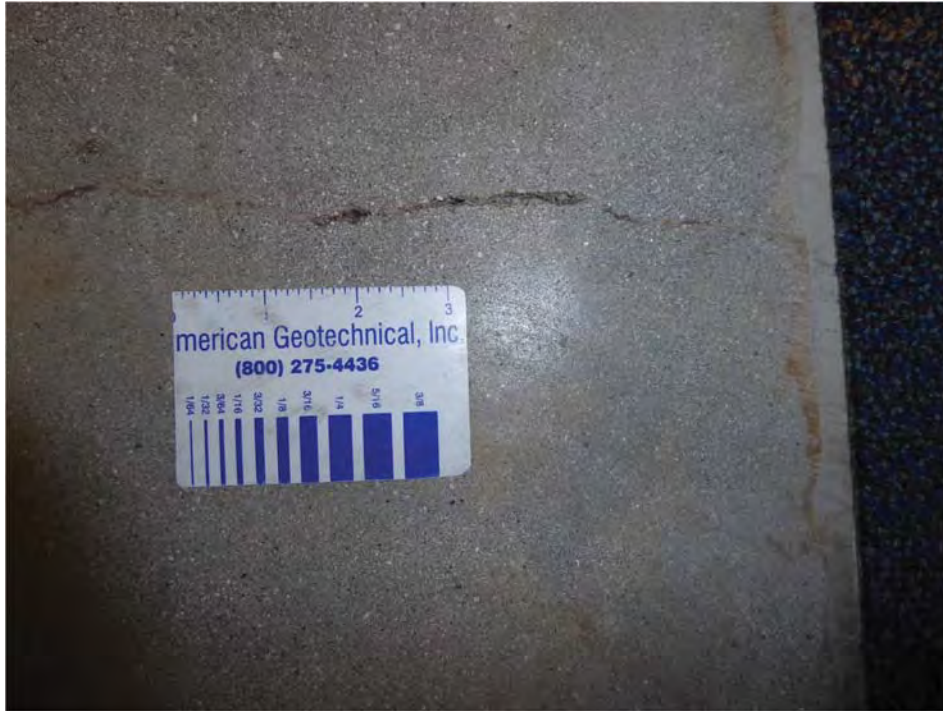
- 1) Plaque
- 2) Outside OV
- 3) Outside door
- 4) Outside OV
- 5) - 9) AGMD-1 OV before prep
- 10) - 12) AGMD-2 OV before prep
- 13) - 15) AGMD-3 OV before prep
- 16) - 17) 1/16" slab ck, exposed after prep

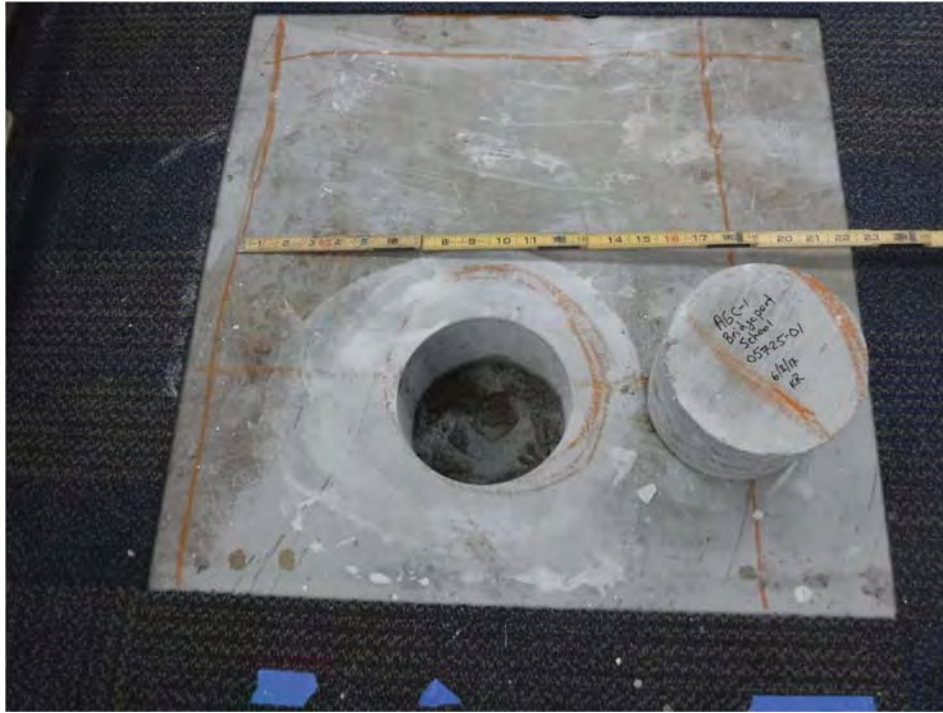
Room A31, AGC-1 - KR 06-03-17 (3)

Depth in Feet	Sample Type	Sample Depth	Field Description	By: <u>KA</u>
			Surface Conditions:	
			Subsurface Conditions:	FORMATION: Classification, color, moisture, tightness, etc.
0.0			0-4 1/2 Conc. Core 6" dia. x 4 3/8 Min 5 1/4" Max thick #4 rebar w/in bottom third of slab space 18" apart E-W, & 11" to 14" apart N-S,	
			4 1/2-7 1/4" SAND BLANKET silty SAND w/f. gravel/v.coarse sand tan, moist (from coring mach.) med. dense	
			7 1/4 Yellow plastic sheet vapor barrier, heavy duty, possibly STEGO WRAP product	
			7 1/4-8 1/4 SAND BLANKET same as above vapor barrier sheet	
			8 1/4-30 1/4" Fill silty SAND w/variable CLAY & some gravel, dk brown to med brown, moist, dense to v.dense

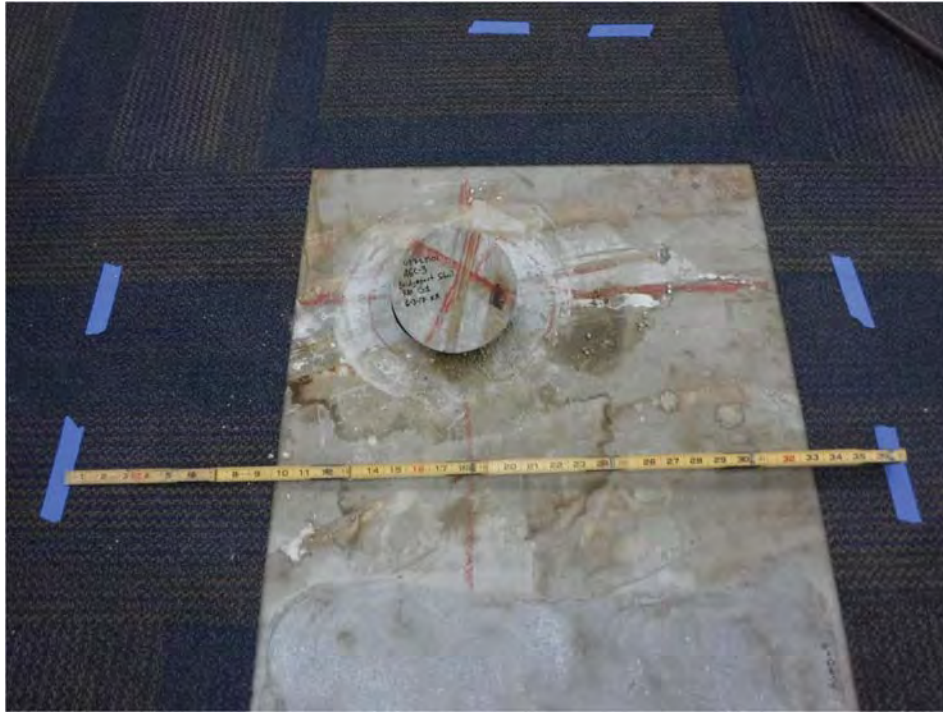
Room C1, AGC-3 - KR 6-3-17 (3)

Depth in Feet	Sample Type	Sample Depth	Field Description	By: <u>KR</u>
			Surface Conditions:	
			Subsurface Conditions:	FORMATION: Classification, color, moisture, tightness, etc.
0.0			<p>0-5" Conc. Core 6" diam. x 4 1/8" Min 5" Max thick #4 rebar in middle third of slab set on rebar chair, &amp; spaced @ 18" apart in E-W direction &amp; N-S direction. ~1/32" slab crack through rebar location.</p> <p>5-6 3/4" SAND BLANKET silty SAND w/some f. gravel/coarse sand med. brwn, moist (from coring machine), med. dense</p> <p>@ 3/4" Heavy duty yellow plastic Moist. barrier sheet, possibly Stego wrap product</p> <p>6 3/4" ~ 8" SAND BLANKET same material as above vapor barrier w/ ~ 1/32" dia f. root underneath vapor barrier</p> <p>8-28" Fill silty SAND w/variable amounts of clay &amp; some gravel med to dk brwn, sl. moist to moist, dense-v. dense</p>

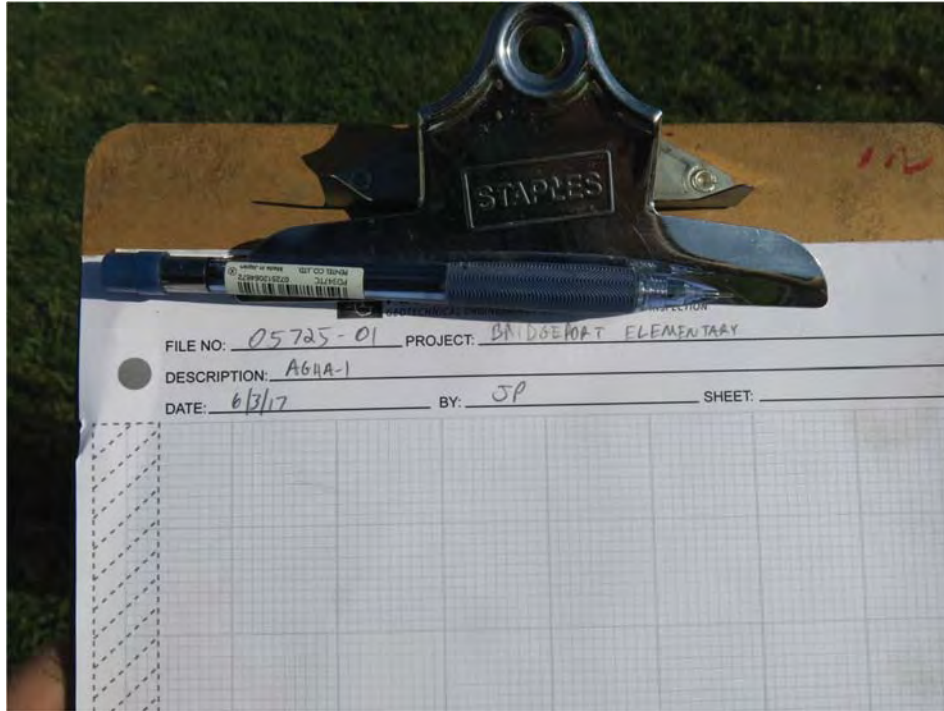
AGHA -1 - JP 6-3-17 (1)

Depth in Feet			
0		0-0.5' <u>Sod &amp; Topsoil</u> , sandy LOAM, moist, soft, abundant roots & organics, dk brown	
0.5		0.5-6.5' <u>Fill</u> silty SAND w/ some gravel & cobbles, sl. moist, med. dense, slightly clayey at 5 to 6.5'	
1		6.5-10.1' silty SAND w/ some clay and gravel, moist, med dense,	
2		* perched ground water encountered at about 7', then becomes dryer (No groundwater) again with depth	
3		Piezometer installed inside auger hole with:	
4		screen interval from 4.4' to 10.1'	
5		solid / Non-screened interval from 0 to 4.4'	
6		Sand pack from 1.5' to 10.1'	
7		Bentonite Seal from 10" to 18"	
8		Soil from 0 to 10"	
9	water tight cap & plastic irrigation cover		
10	H <sub>2</sub> O @ 7.6' depth after installation then piezometer was bailed		
	<u>Samples:</u>		
	T @ 0.5-1.5'	T @ 7.5-8.0'	LBC 0.5-5.0'
	↓ 2.5-3.5'		↓ 5.0-6.0'
	↓ 6.5-7.0'		↓ 8.0-10.1'

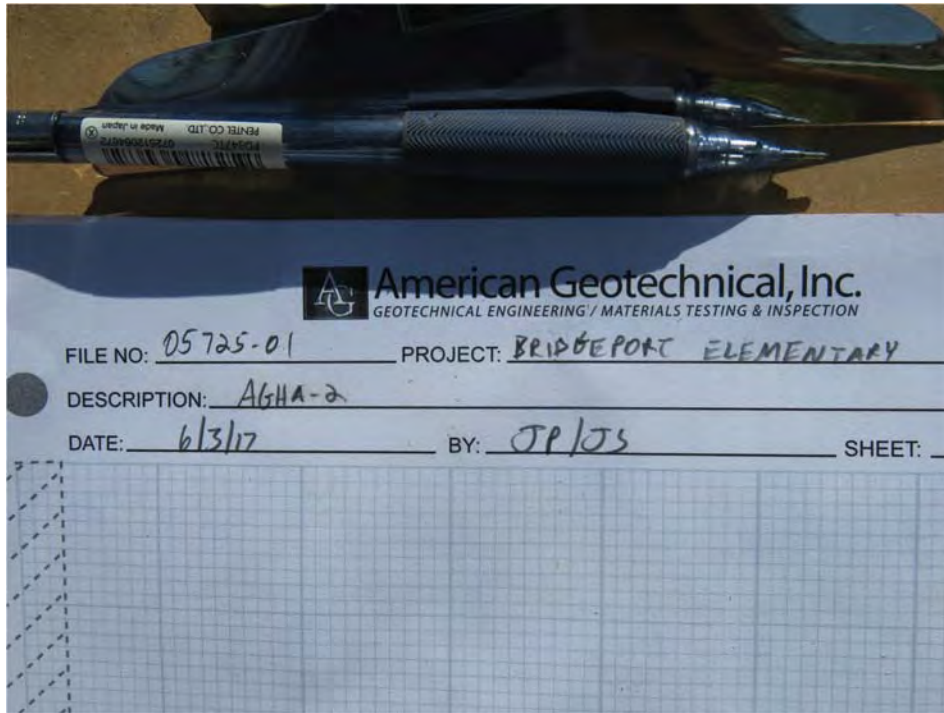
AGHA-2 JP 6-3-17 (1)

0-0.5' <u>Topsoil + Sod</u> sandy LOAM, dk brown moist soft
2			0.5-5.0' <u>Fill</u> silty SAND w/ some clay & gravel yellow-brown, med. dense, slightly moist, occasional sub-round cobbles to ≥ 3.0" diam. trace organics, refusal on large cobble at 5.0'. No groundwater encountered
3			Piezometer installed inside auger hole with: screen interval from 2.0'-5.0' solid / non-screened interval from 0-2.0' sand pack from 1.5'-5.0' Bentonite seal from 0.5 - 1.5' Soil from 0-0.5'
4			<u>Samples:</u>
5			T @ 0.5-1.5'      LB @ 0.5-5.5'
			↓ 2.0-2.4'
			↓ 4.0-4.5'
			↓ 5.0-5.5'

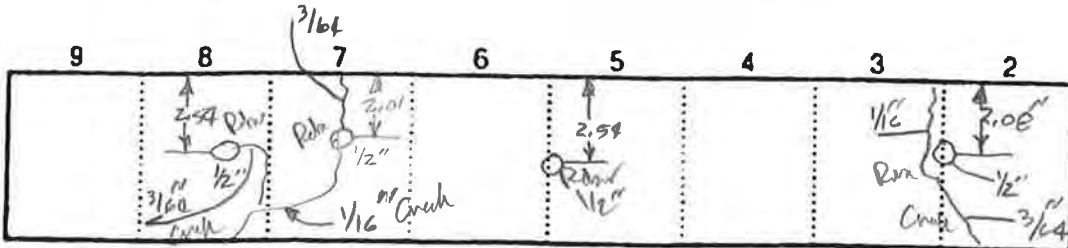
COMMENTS CRACK COMPLETELY THROUGH THE CORE.
