Exponent
475 14th Street, Suite 400
Oakland, CA 94612

Subject: Focused Destructive Inspection at Bridgeport Elementary School
Saugus Unified School District, Valencia, California
Exponent Project No. 1703766.000

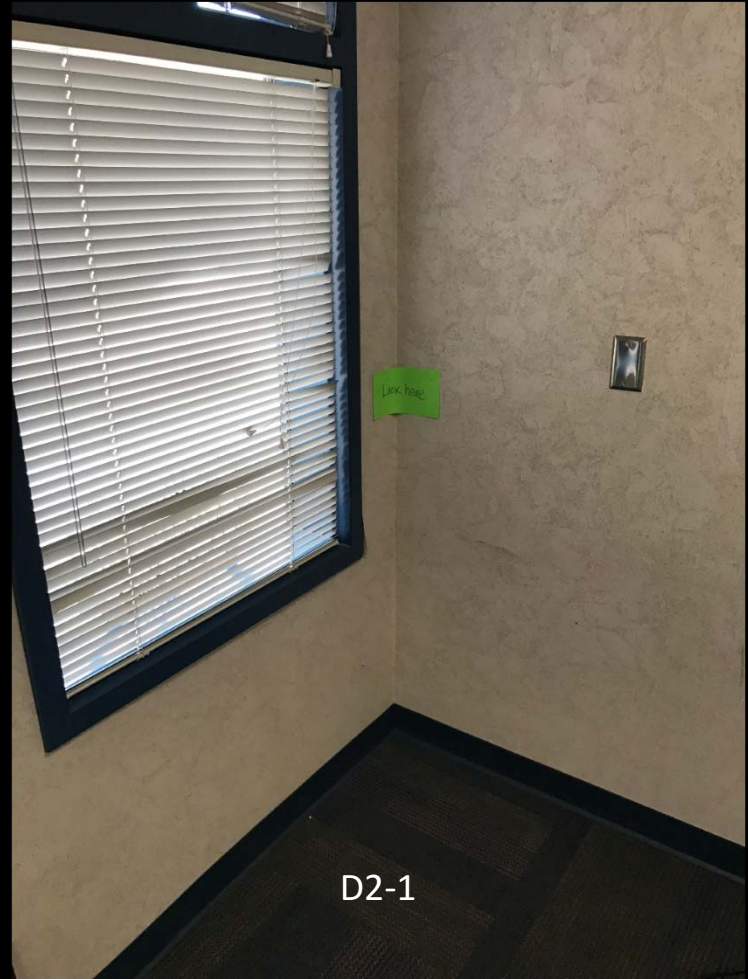
D2-1

- The areas identified in Rooms D2 and E3 should be remediated by a licensed mold remediation contractor following standard industry practice at the conclusion of the 2018 school year. Stained and affected building materials should be removed (including any drywall, any stained insulation, and wallpaper, if within the impacted area). The full extent of these stained areas was not determined during this inspection, particularly for the area observed in Room D2. The source of the leak or source of water should be identified and repaired prior to remediation. After remediation, a post-remediation inspection should be conducted by a third party inspection.
